technically speaking

VOLUME 22/ISSUE 1
February 1, 1998

Proper vs. Improper Truck Nail Hole Repair

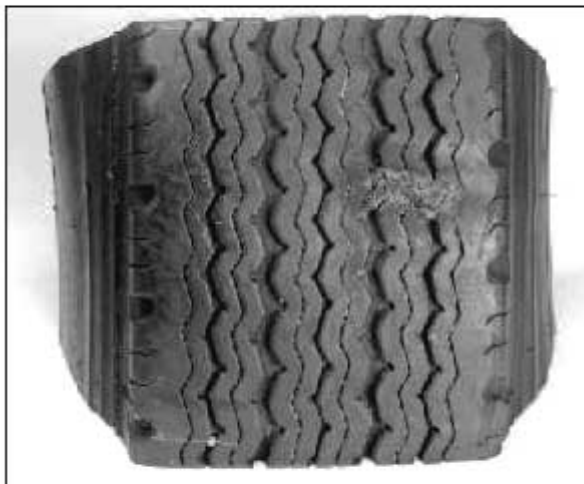
Photo 1 shows an on-the-wheel or plug only tire repair which is not recommended by any industry association or tire manufacturer.

The use of this type of repair does not allow for complete tire inspection or injury analysis.

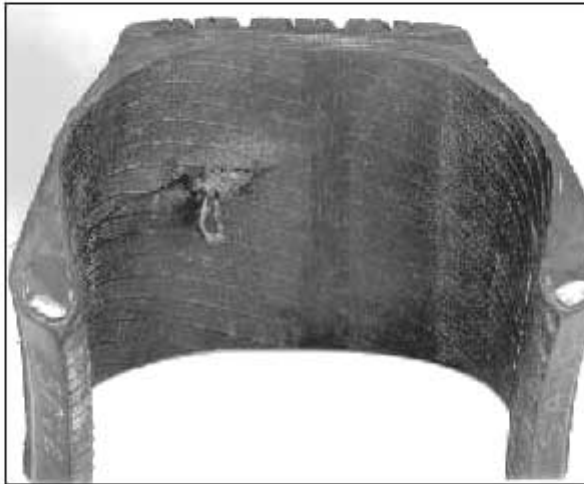
2

The results of using this improper repair method are shown in Photo 2. An on-the-wheel repair does not seal the innerliner or support the injury, thus resulting in premature tire failure. This type of repair and its potential consequences magnifies the importance of removing the tire from the rim and using industry approved repair procedures.

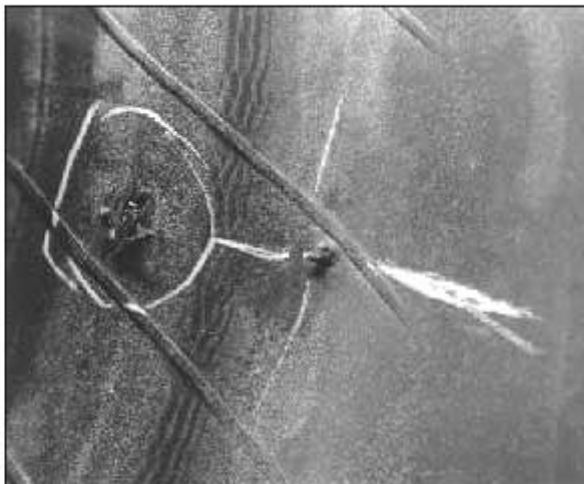
Photo 3 illustrates the importance of removing the tire from the wheel assembly for a thorough inspection before beginning the repair process.

The sharp object in the center of the photo penetrated the tire through the tread area. The tire began to lose air pressure causing severe deflection of the sidewall areas and eventual contact with the penetrating object. This created the internal damage which is circled in Photo 3. Notice the tubeless innerliner is damaged along with the radial cord body plies.

Obviously this tire is not repairable, but illustrates the necessity for inside inspection of all tires.

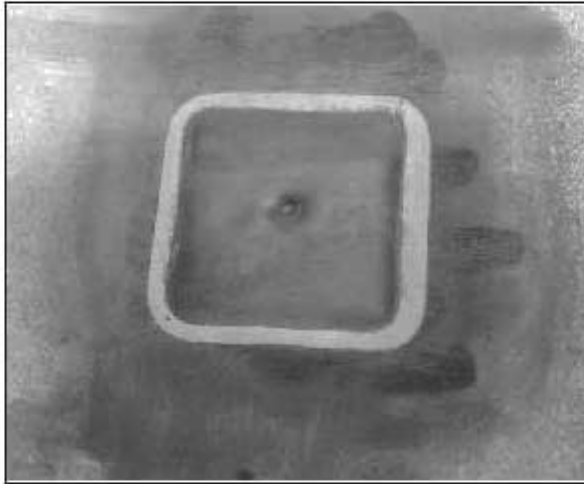
Using a repair unit (patch) only over the damage on the inside of the tire is not satisfactory.

Photo 4 illustrates the patch-only repair. Notice the depression, or dimple, in the repair unit. The internal air pressure of the tire is forcing the repair unit into the unfilled injury, which eventually will create tire failure due to tire repair failure.

Without filling the injury, the cord body and belt package are exposed to further contamination resulting in injury growth, cord deterioration/separation, premature failure, or possible total tire destruction.

The industry requires the filling of the injury along with ensuring that the appropriate repair unit is placed over the injury for support and sealing of the innerliner, as criteria for a proper tire repair.

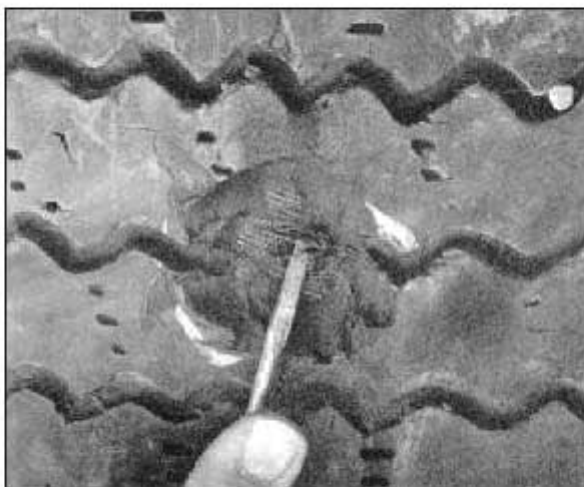
5

As shown in the above photo, severe rust, separation and steel cable looseness will not permit further repair of this tire. TECH always advocates "filling" the injury on "all" tires to ultimately preserve the casing for retreading, to fulfill the tire manufacturers' warranties, and to reduce liability.

Punctures in the sidewall area of steel radial truck tires should be considered a section repair and sent to a full service tire repair facility.

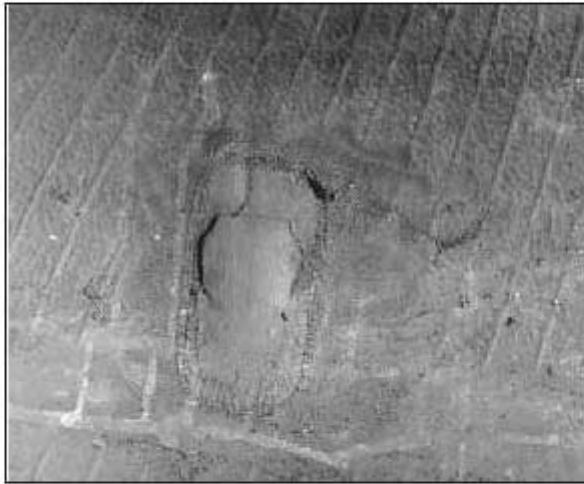
Photo 6 shows a repair unit which failed when placed over an injury in the sidewall area of the tire. Notice that the repair unit's reinforcement package has fatigued and is loose. Also notice the deep depression extending outward through the top side of the repair unit.

In this case, the depression is caused by the steel body cables pulling away from the injury due to improper repair techniques.

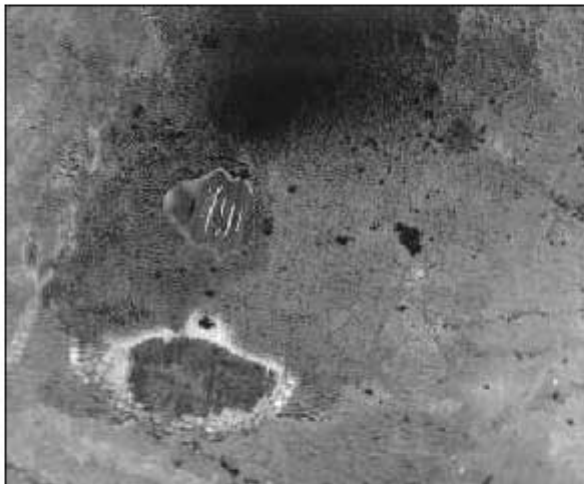
Photo 7 illustrates damage to the steel body cord after the failed repair unit was removed. The injury was too large for a small nail hole repair unit to reinforce properly, the injury was not prepared or filled, and now the injury has grown larger due to improper repair techniques. This injury should have been a section repair.

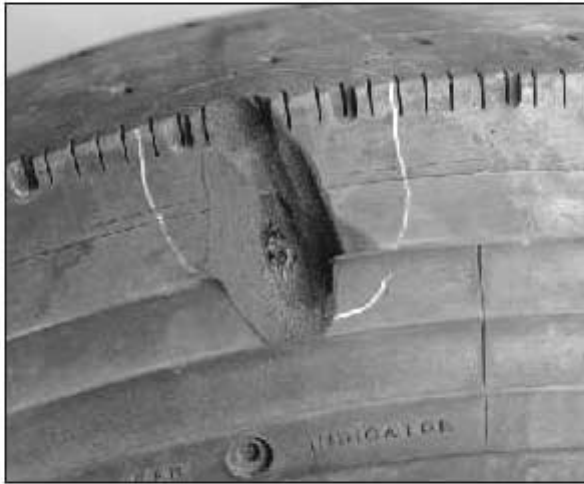
Photo 8 allows you to see the damaged cord body once the sidewall rubber was removed. A proper section repair could have extended the performance expectations of this tire.

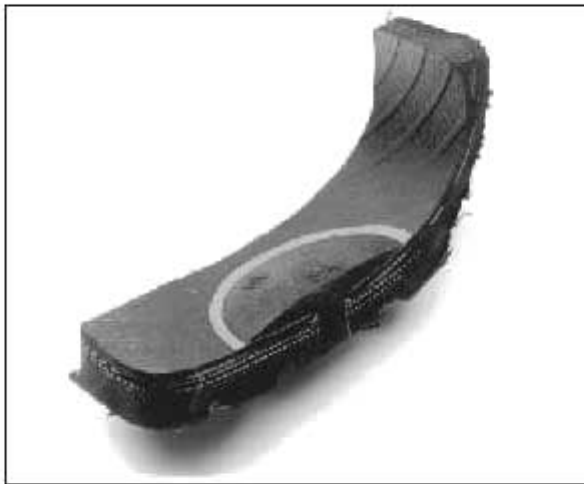
Photo 9 is a cross section of a proper tire repair that illustrates proper injury removal, a complete seal of the injury, and reinforcement of the innerliner to protect the integrity of the tire without sacrificing the safety of you or your customer. It is just as easy to repair a tire properly as it is to improperly repair a tire.
